# Status of Fukushima Daiichi Nuclear Power Station

**Apr. 25, 2014**

**Tokyo Electric Power Co., Inc.**

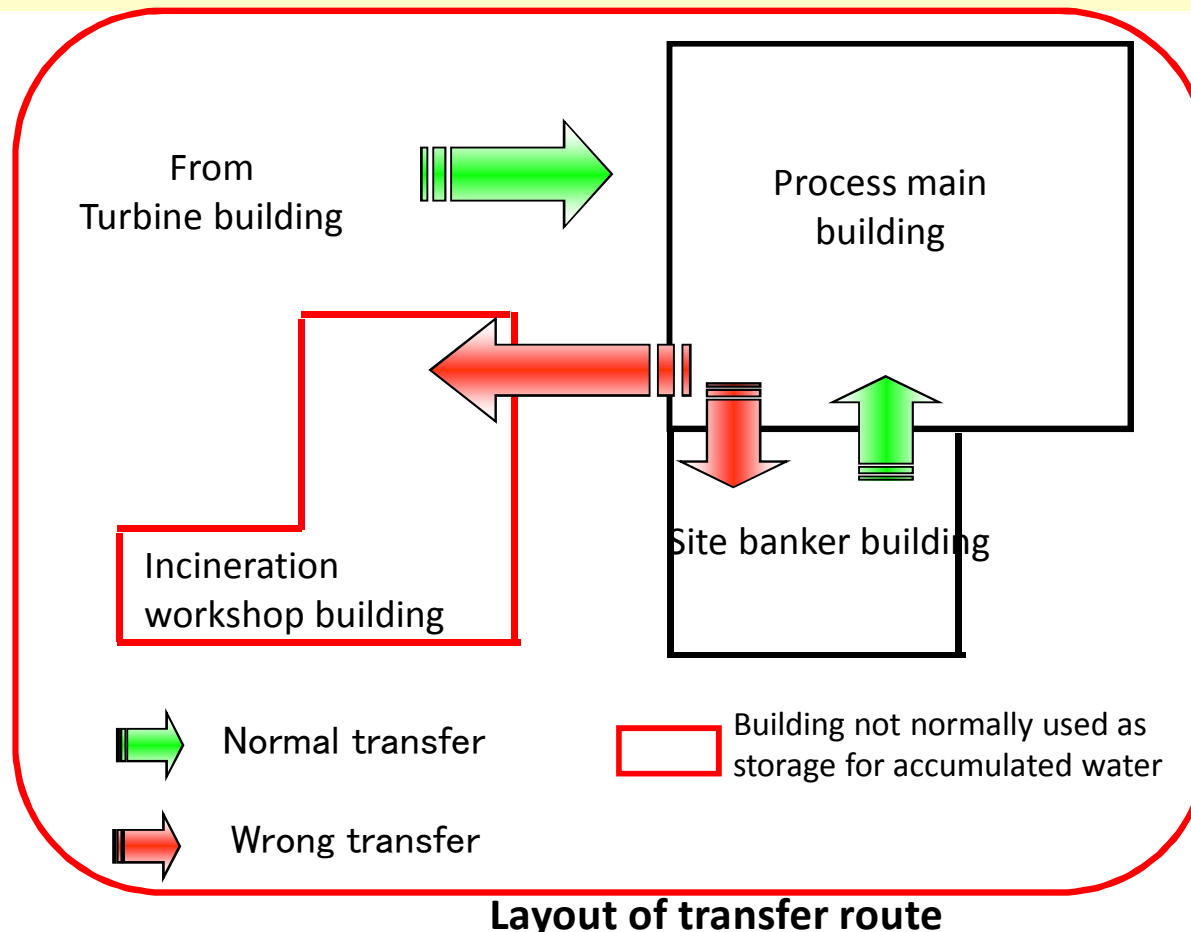
- Since Four temporary pumps, which is normally not used (Process main building → Site banker building : One unit, process main building → Incineration workshop building: One unit, Incineration workshop building → Process main building : Two units) was operated, accumulated water was transferred from process main building to the incineration workshop building, which is supposed not to store it.
- Now accumulated water in the incineration workshop building is being transferred to the process main building (Apr. 14- ). As countermeasures for management, security of power panel, control of valve, and locking of building/door are enhanced.

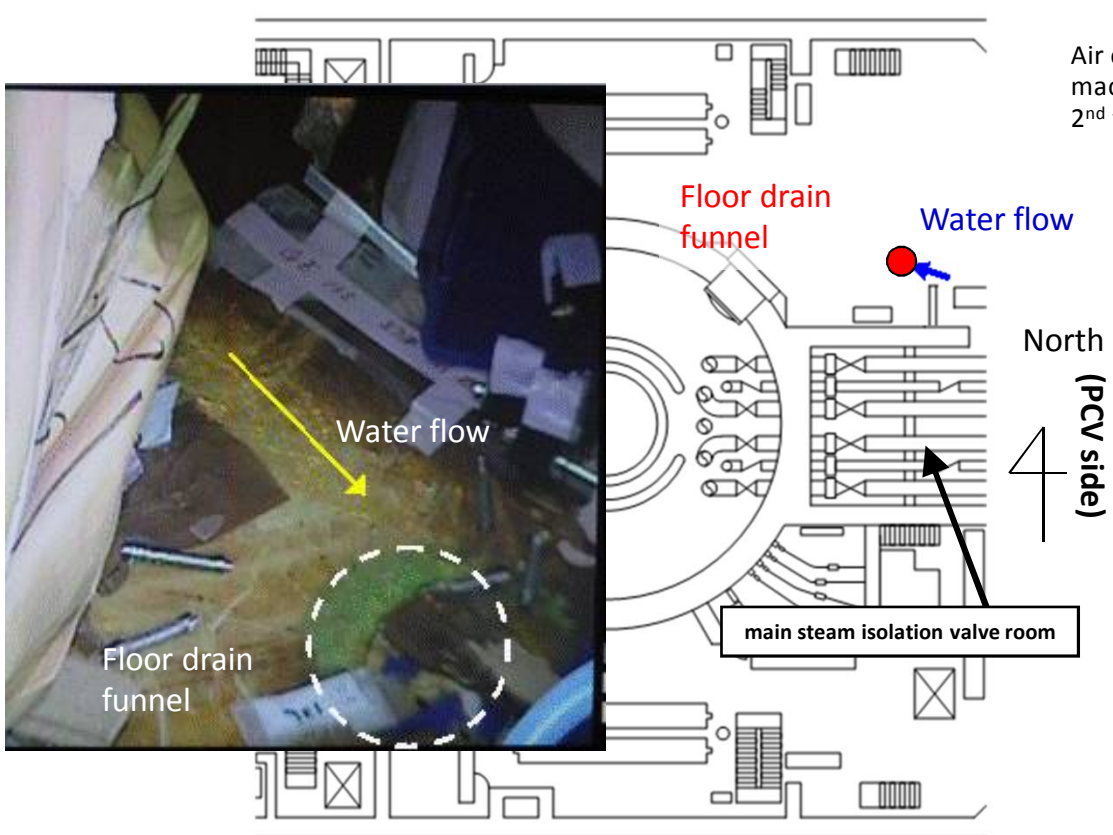
Outline of water flow condition

- Water flow was confirmed to be flown from around the door of the main steam isolation valve room located in the northeast area of 1st floor of reactor building into adjacent floor drain funnel (outlet) on Jan. 18. The outlet is connected to the basement stairs of reactor building, and it will not be leaked outside the building.
- Based on the results of temperature of water flow and radioactive material , drawings etc., accumulated water is expected to exist in the PCV.
- From Apr. 23, started to conduct image acquisition by the camera and dose measurement for the piping for instrument that connected air conditioning machine room on the 2<sup>nd</sup> floor of reactor building and main steam isolation valve room of 1st floor.

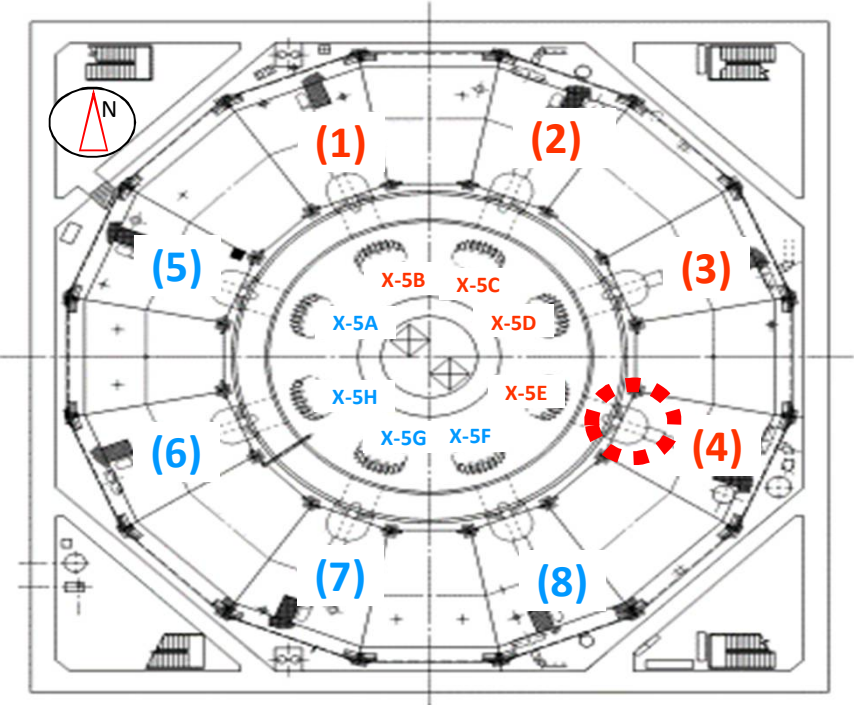
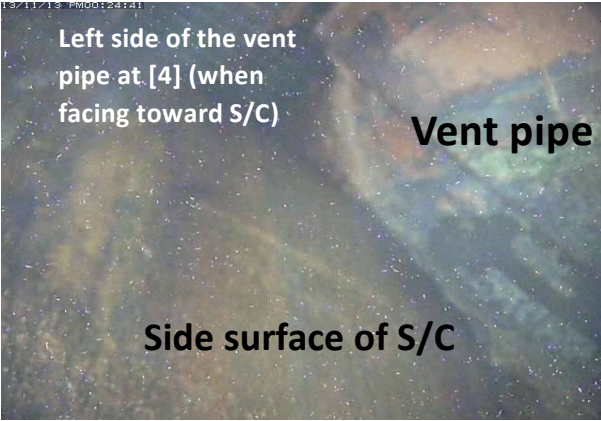
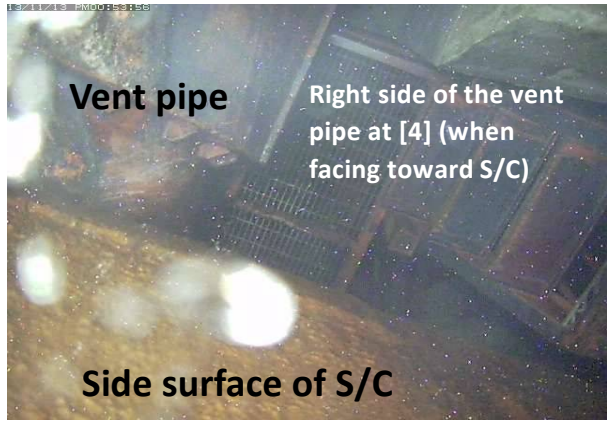
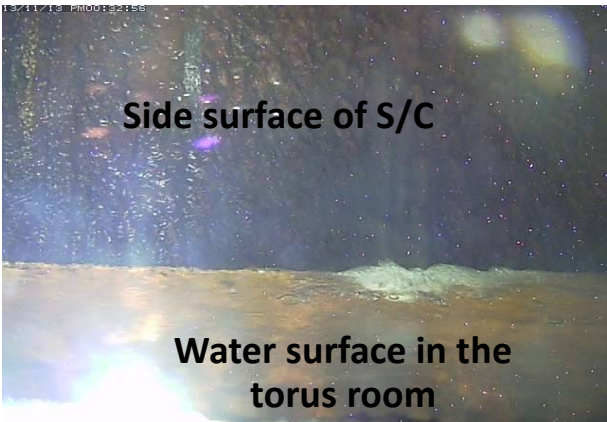
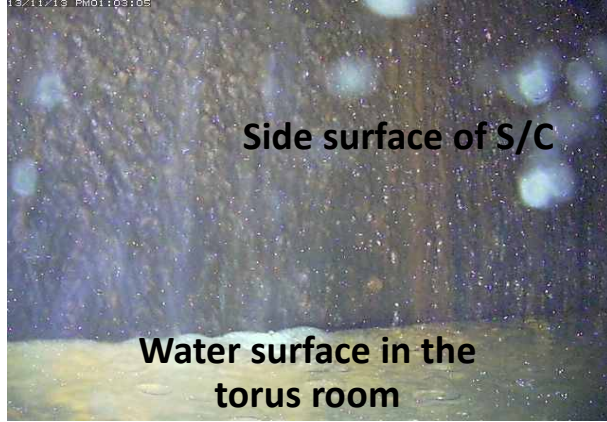
➤ Investigation results of suction drain pipe  
Water was confirmed to be flown downward on the surface of S/C from the direction of upper part of the S/C of vent pipe [4].  
No leakage was found between [1]- [3] and [5]- [8].

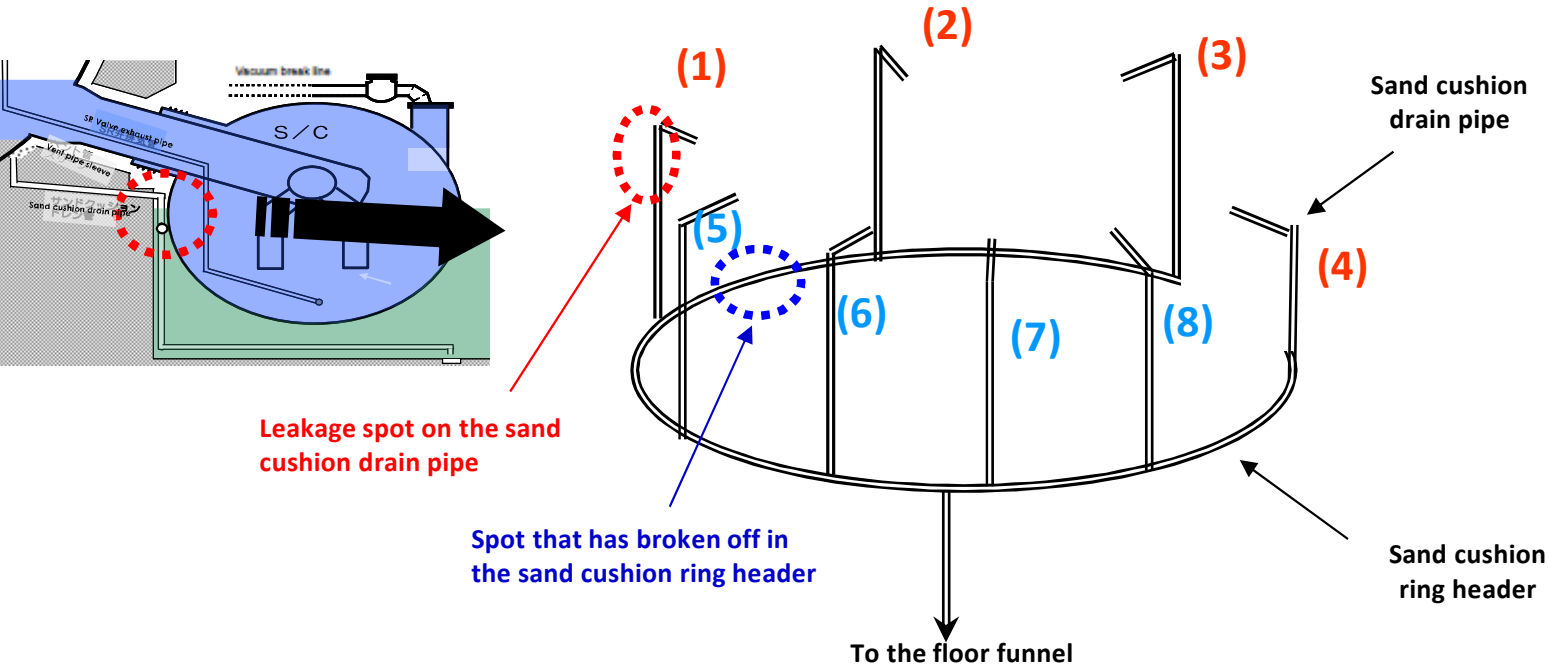
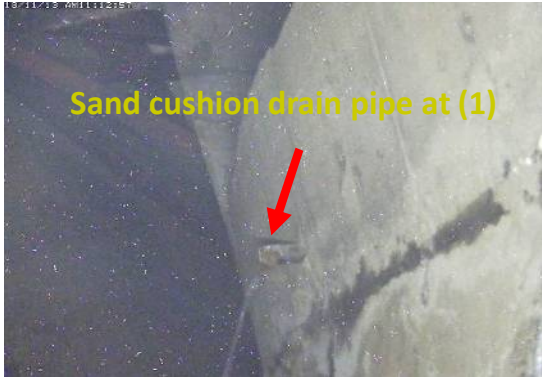
- Investigation results on the sand cushion drain pipes
  - Damage and leakage were found on the sand cushion drain pipe at [1].
  - Drain pipe was not damaged and there was no water flow between [2] and [8].
  - The sand cushion ring header was found to have been damaged between [1] and [2].
