# Status of Fukushima Daiichi Nuclear Power Station

**Apr. 25, 2014**

**Tokyo Electric Power Co., Inc.**

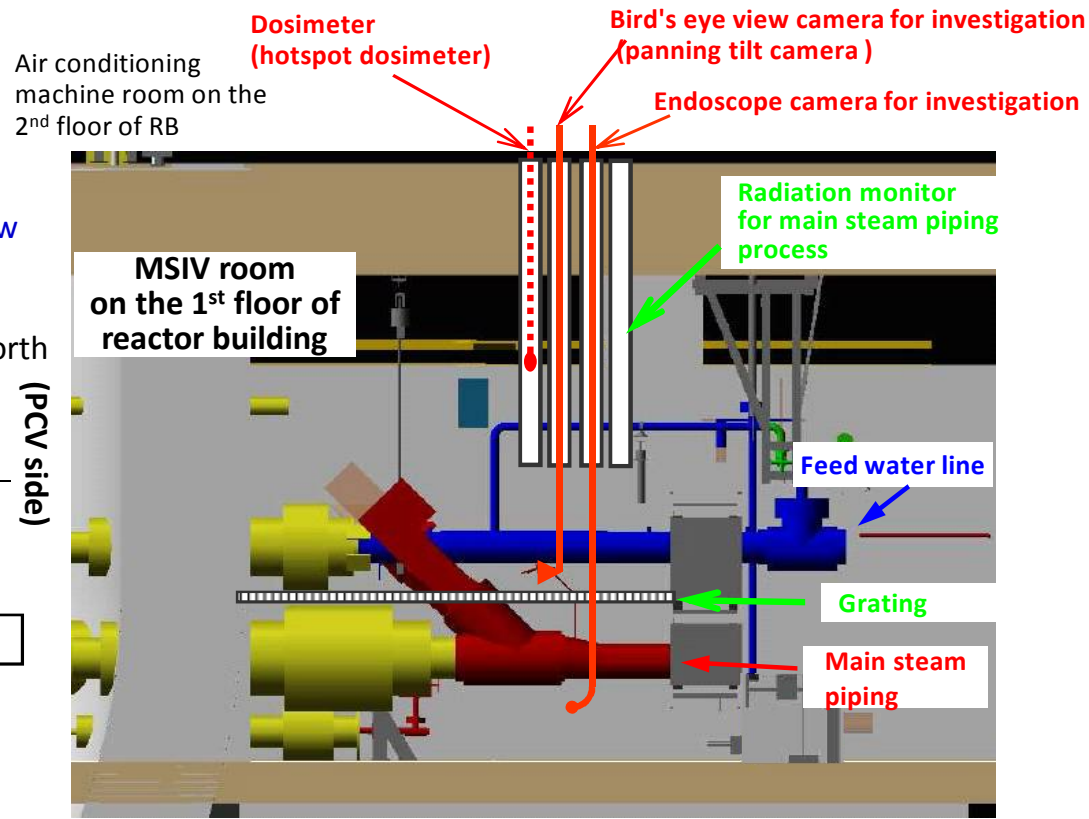
MSIV room on the 1st floor of reactor building (cross section)

- Water flow was confirmed to be flown from around the door of the main steam isolation valve room located in the northeast area of 1st floor of reactor building into adjacent floor drain funnel (outlet) on Jan. 18. The outlet is connected to the basement stairs of reactor building, and it will not be leaked outside the building.
- Based on the results of temperature of water flow and radioactive material , drawings etc., accumulated water is expected to exist in the PCV.
- From Apr. 23, started to conduct image acquisition by the camera and dose measurement for the piping for instrument that connected air conditioning machine room on the 2<sup>nd</sup> floor of reactor building and main steam isolation valve room of 1st floor.

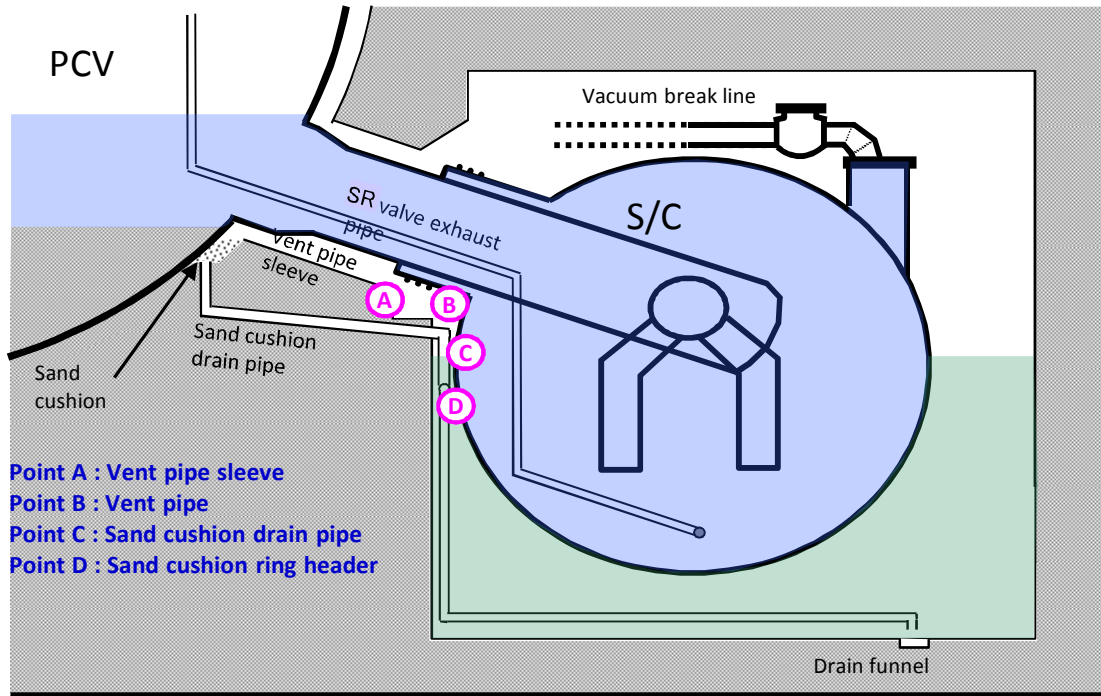
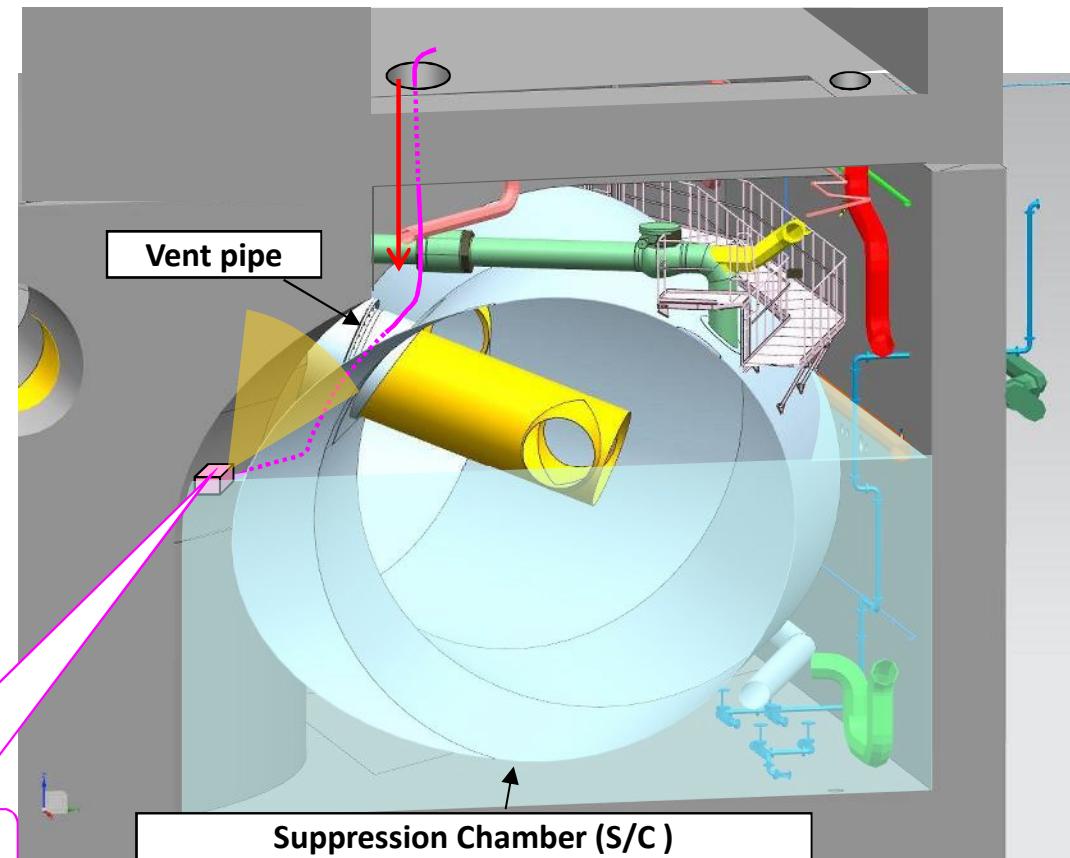
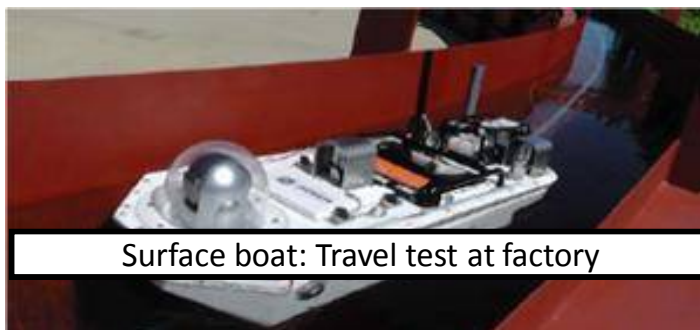
- In preparation of PCV repair (water stoppage) required for fuel debris retrieval, conducted investigation around the lower part of vent pipe to estimate point of leakage from PCV.
- Leakage from the vent pipes and the sand cushion drain pipes, and the external conditions of these pipes were checked using images captured by cameras mounted on a surface boat.

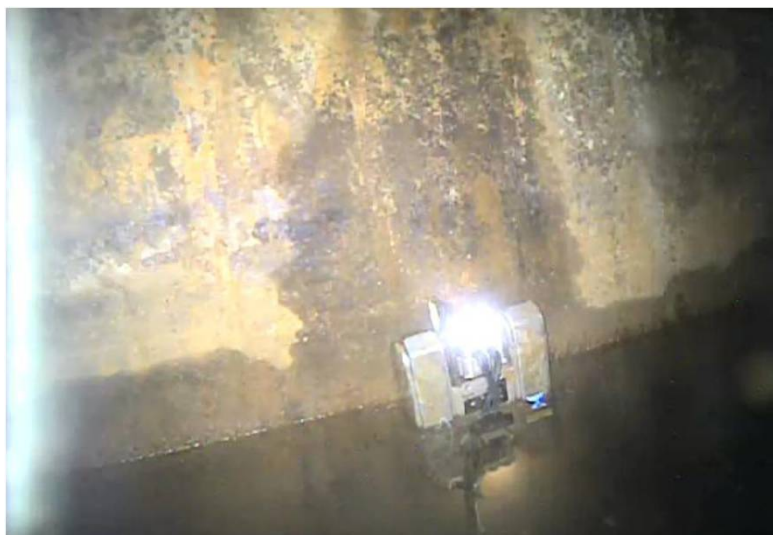
During of the water level measuring

➤ The measuring was conducted from January 14 to 16 at multiple lines (multiple longitudes) in order to enhance the reliability of specifying the exact water level. The numerical values of January 14 and 15 in the following chart were obtained in the middle of the series of the data collecting work.

[Note] It is estimated that the water level inside the S/C is influenced by the change of the water level of accumulating water inside the torus room.
