# Reference information for each project

Ministry of Economy, Trade and Industry

Agency for Natural Resources and Energy

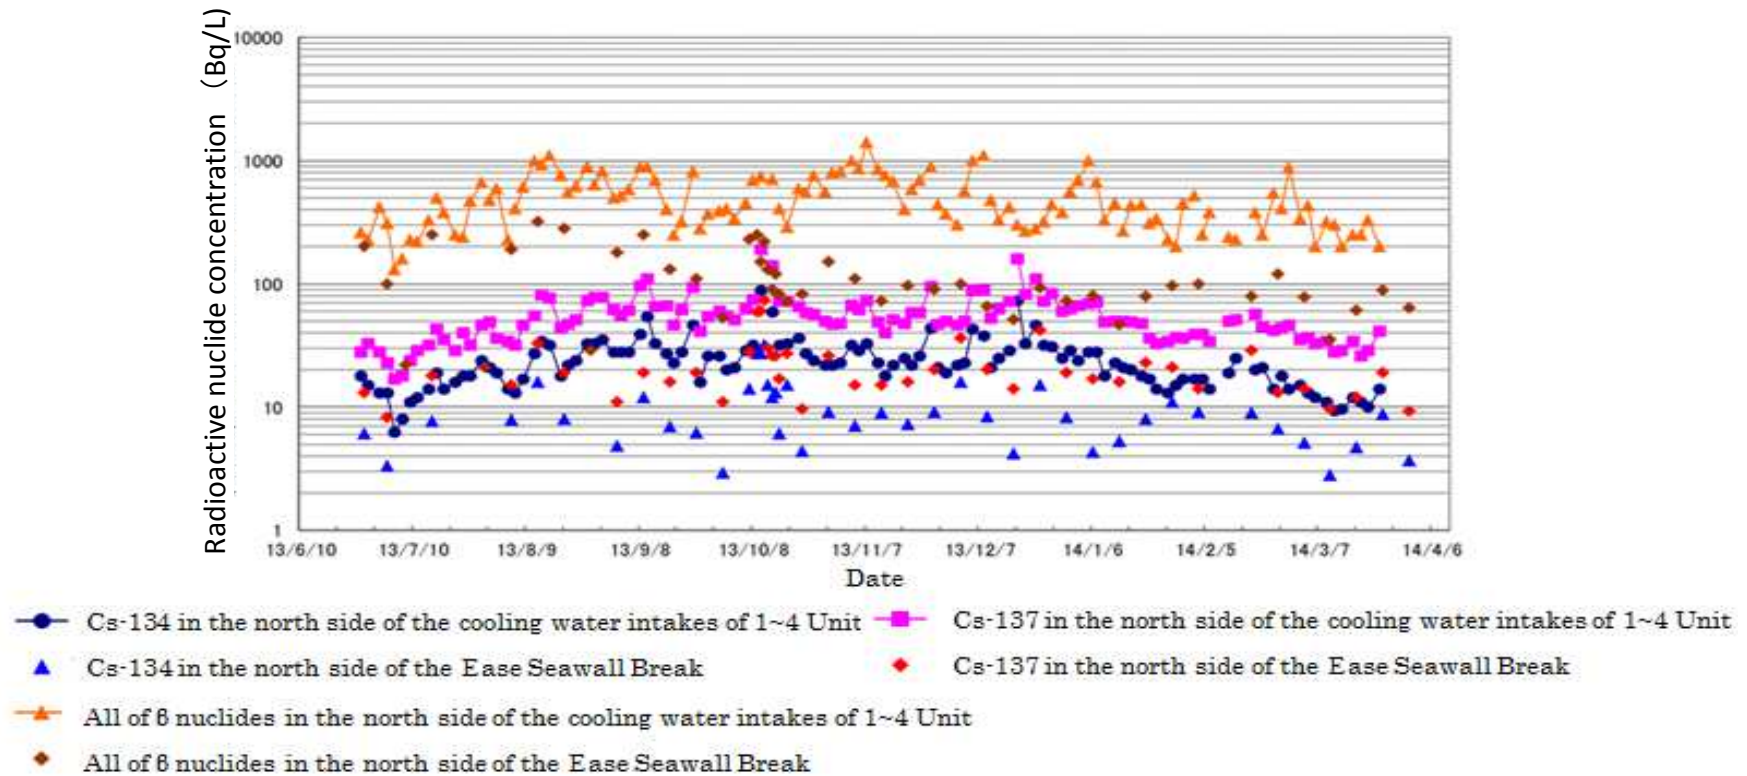
## Change of radioactive nuclide concentration in the seawater (for Demonstration Project for Seawater Purification Technologies)

Change of radioactive nuclide concentration in the north-side area of Unit 1 through 4 cooling water intakes and north-side area of the Ease Seawall Break

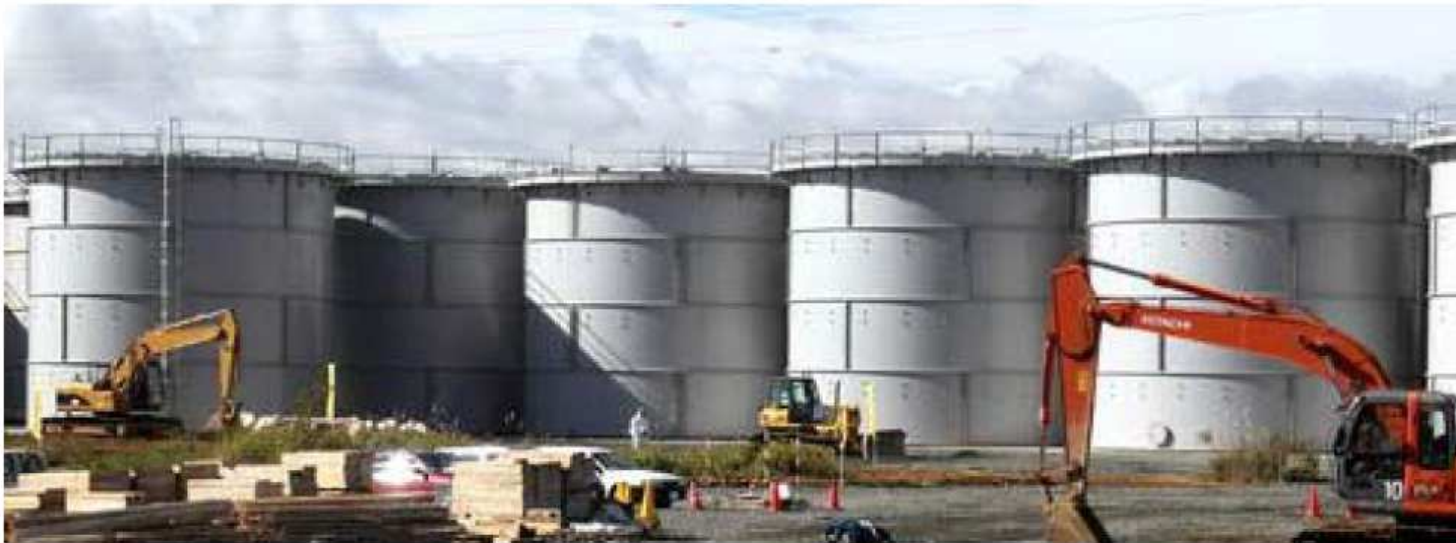
(1) Type of tanks to be disposed

Cylindrical flange-joint type tank

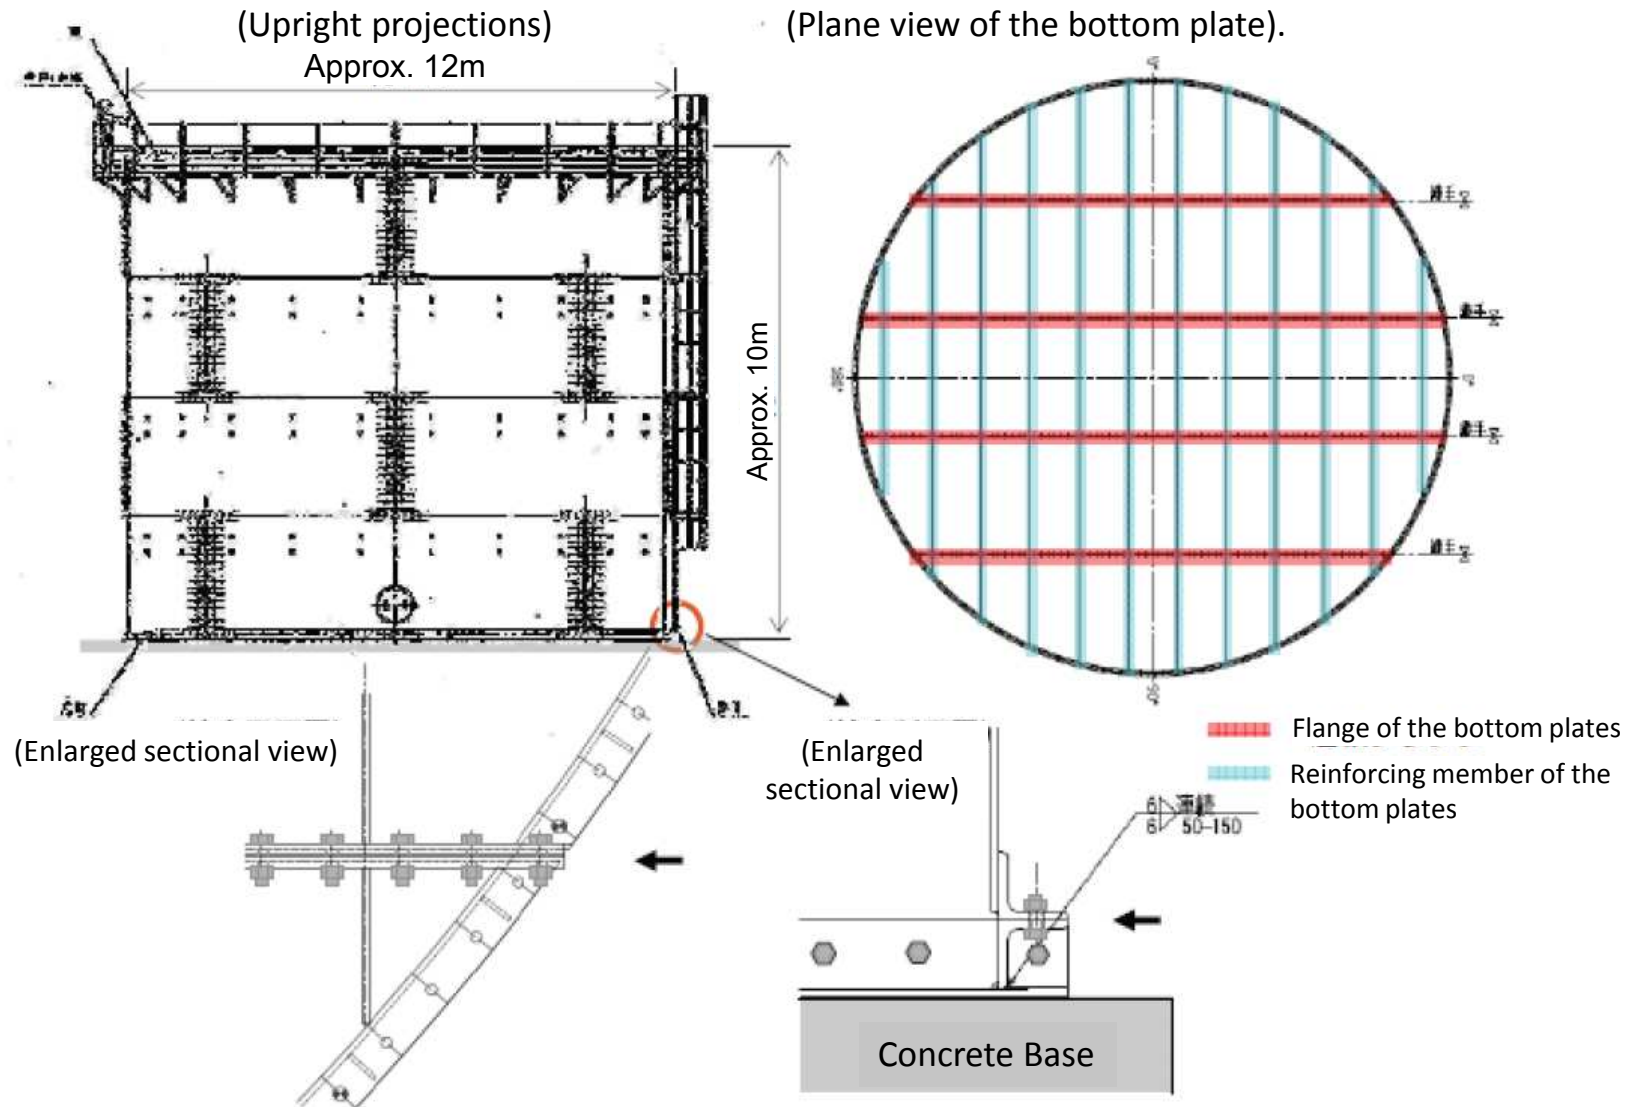
# Structure of the tank to be disposed

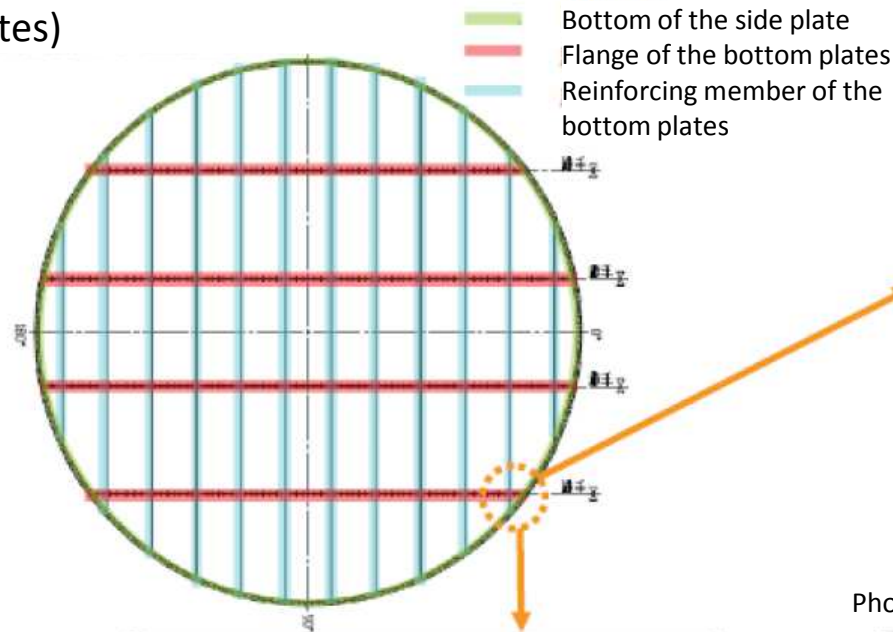
# Structure of the bottom panels of the tank to be disposed

(Plane view of the bottom plates)

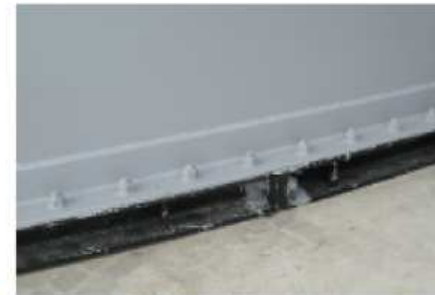
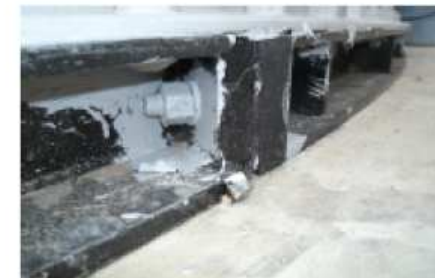
Photo of the joint part of flange at the bottom of the tank

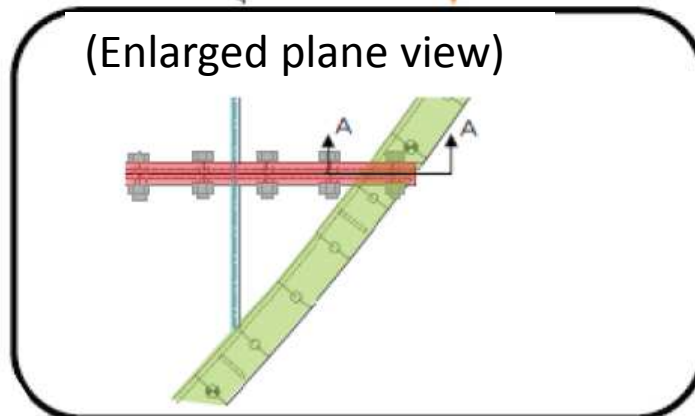
(Enlarged plane view)

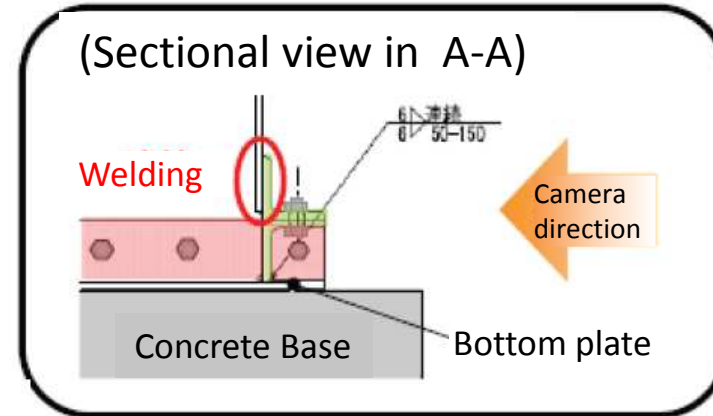
(Sectional view in A-A)

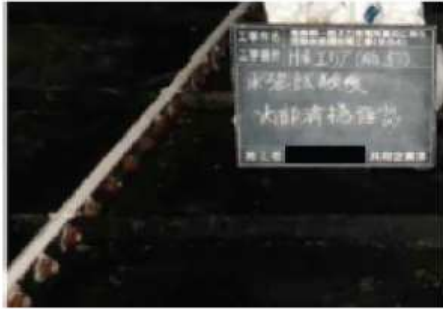
Cross-section view of bottom plates waterproofing structure	Construction example
Type-1	<p>Water expanded waterproofing materials</p>

<p>Sealing materials</p>

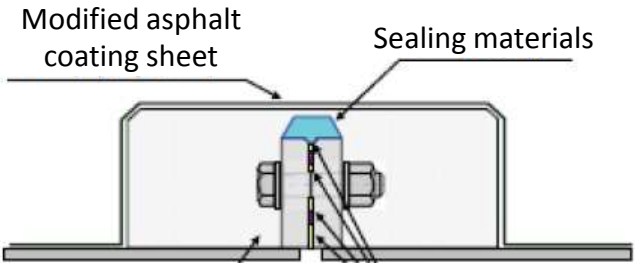
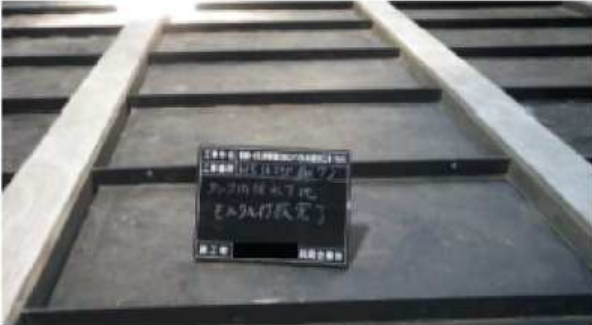
Type-2	<p>Modified asphalt coating sheet</p>

<p>Sealing materials</p> <p>1:2 mortar</p> <p>Water expanded waterproofing materials</p>

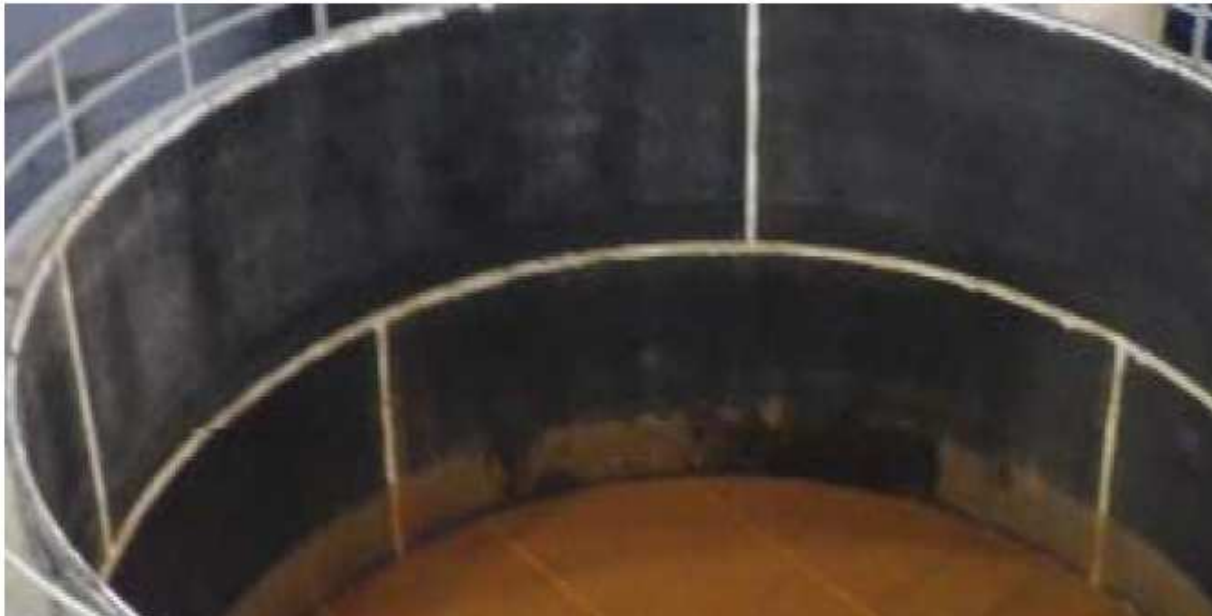
Photo of side structure of the tank (joint section)

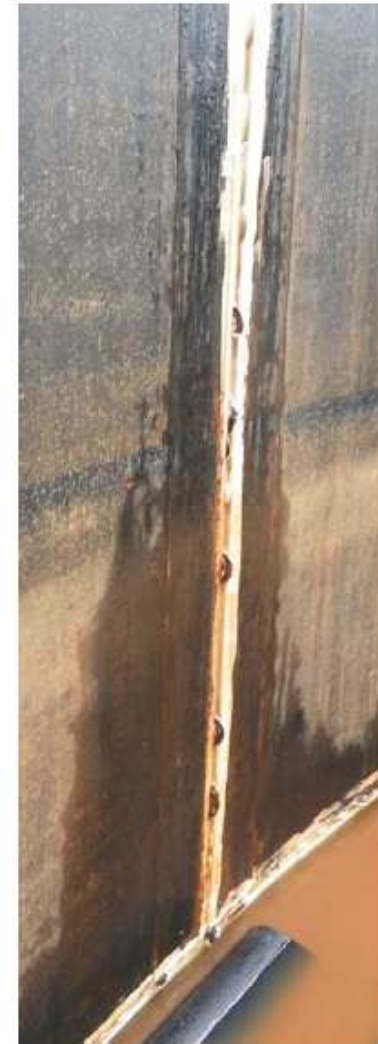
Joint for side  
of a tank

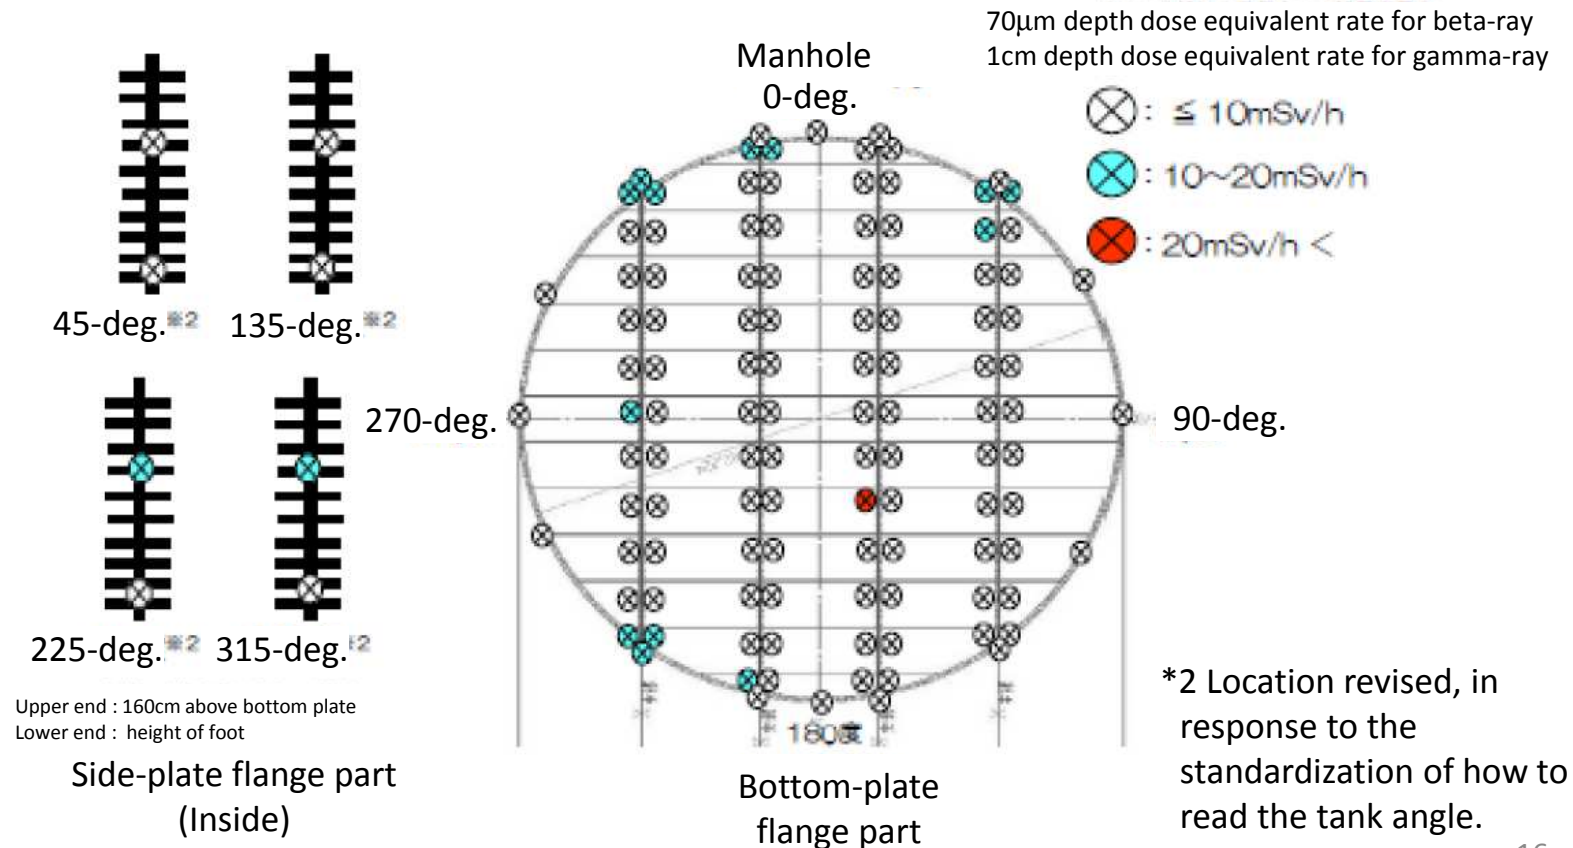
## Measured dose rates in the tank (H4 area No.5)

The dose rates measured around flanges were below 10mSv/h for beta-rays at almost points, and the maximum was approx. 22mSv/h. Dose rates from gamma-ray were 0.02 – 0.125 mSv/h

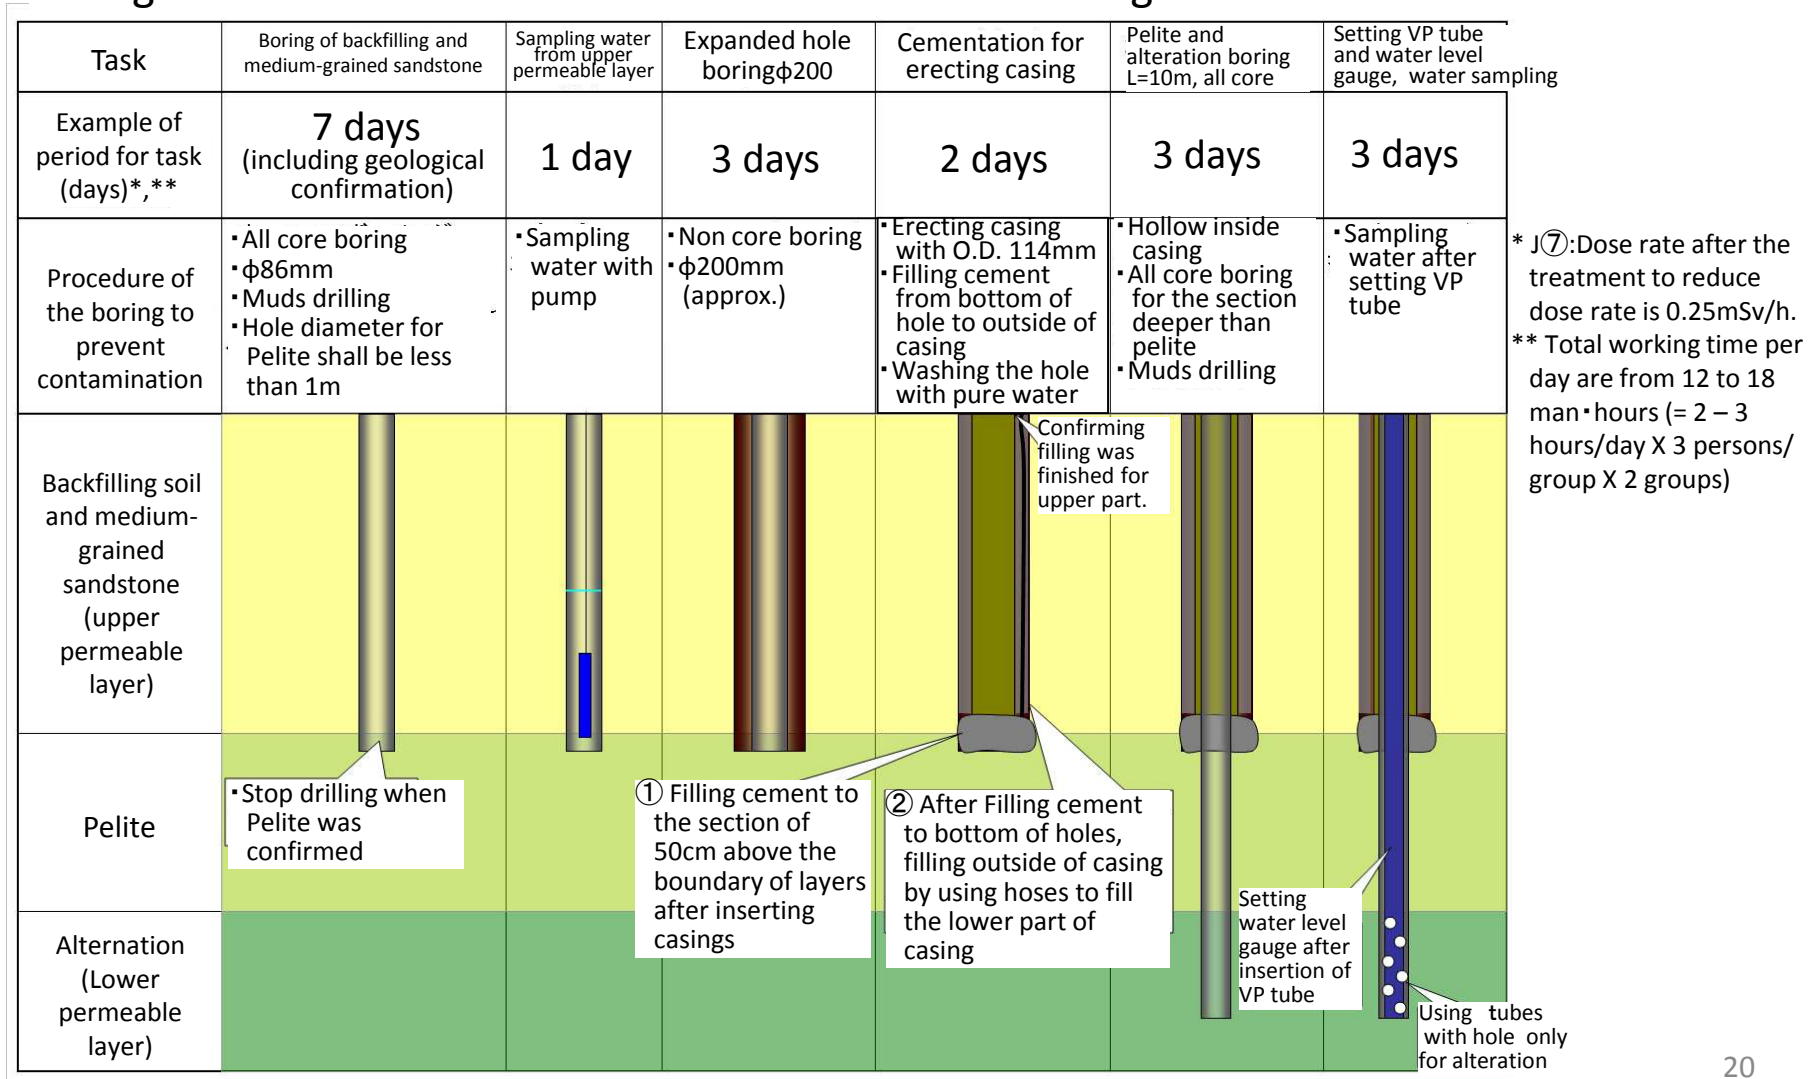
## Boring for groundwater survey

(example of construction for contamination measure L:25-30m    Period : approx. 10 – 20 days)

The countermeasures shall be required not to expand the contamination to other layers if boring halls are drilled in the area with the risk of soil or groundwater contamination.
